THESIS

**SODIUM SULFATE CORROSION OF SILICON CARBIDE
FIBER-REINFORCED CALCIUM ALUMINOSILICATE
GLASS-CERAMIC MATRIX COMPOSITES**

March, 1994

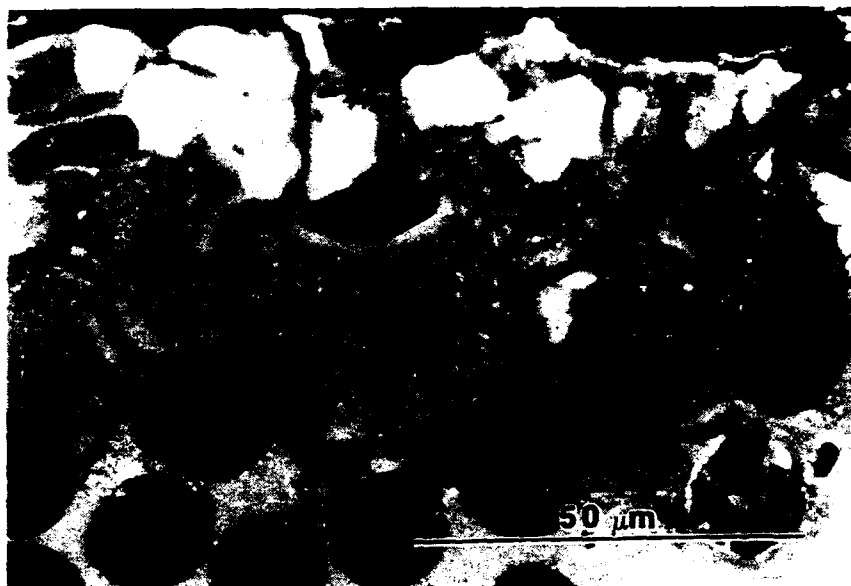
Figure 20. BSE Micrograph of Na_2SO_4 Coated SiC/CAS Composite Heat Treated in Air at 900° C

Scanning electron microscopy performed on the Na_2SO_4 coated SiC/CAS composite heat treated in air to 900 °C revealed corrosion along the entire surface of the composite. The extent of the corrosion is controlled by the rate of oxygen diffusion into the composite which results in the degradation of the SiC-fiber and glass-ceramic matrix. Oxygen diffusion may be enhanced by the presence of matrix cracking which acts as a transport mechanism for corrosion products to the inner matrix and reinforcing fiber regions. The corrosive reaction zone was approximately 20-50 μm deep into the composite (Figure 20).

Significant matrix/fiber attack is evident in the coated sample (Figure 20) as compared to the lack of degradation of the composite in the uncoated sample (Figure 21).

The wollastonite morphology is represented as globular bright phases in Figure 20. The rankinite forms as needle like phases as in Figure 24. Advanced x-ray imaging indicates high calcium concentration in the needle like structure (Figure 25).

The two phase glassy regions, shown in Figure 20, are characterized by a dark grey phase near the surface and a lighter grey phase near the middle of the reaction zone. EDX analysis was performed on the light grey region and is presented in Figure 26. This region is believed to

EDX analysis (Figure 27) was performed on the dark grey phase that forms at the surface (Figure 20). This analysis indicates a dominently high concentration of silicon. This dark phase also forms as a silicon rich ring around fibers as they degrade (Figure 28.) Advanced x-ray analysis of this ring (Figure 29) indicates a silicon rich region surrounding the degraded fiber.
